NIST Technical Note 1477

Testing of Portable Radios in a Fire Fighting Environment

August 2006

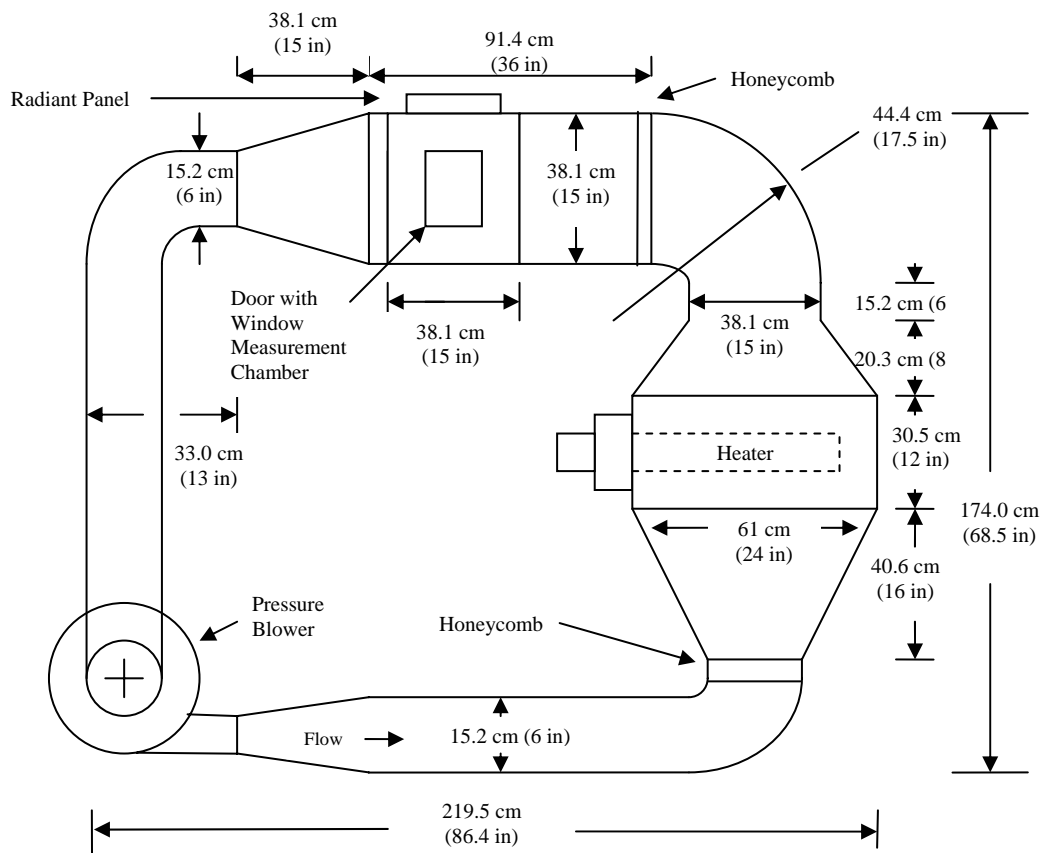
Figure 1 Diagram of Fire Equipment Evaluator (FEE)

Testing of the radios was performed using the Fire Equipment Evaluator (FEE). The FEE is a closed-loop, recirculating wind tunnel designed to simulate thermal conditions up to Thermal Class III. A diagram of the FEE is shown in Figure 1. It consists of a stainless steel enclosed, fan driven, air flow loop 219.5 cm (86.4 in) long by 174 cm (68.5 in) high. The testing section is 910 mm (36 in) long with a cross section of 380 mm² (15 in²). It is capable of reaching

temperatures up to 300 °C (572 °F) and velocities from 0.5 m/s to 2.0 m/s. Temperature measurements inside the FEE were made using type K (Chromel-Alumel) thermocouples, each with a bead diameter of 1.0 mm ± 0.2mm. A bidirectional probe was used for the velocity measurement. Details of the FEE can be found in Donnelly, *et al*, 2006.

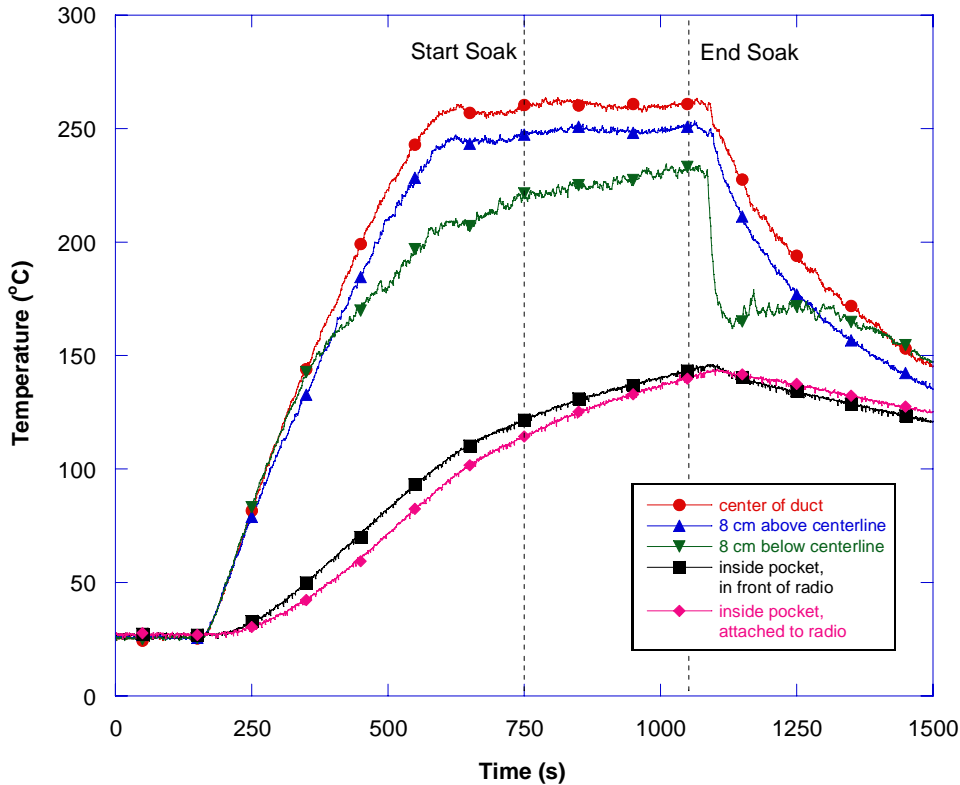
Figure 2 Plot of Temperatures inside and outside of pocket.

For the elevated temperature tests, the radio was placed into the test tunnel at ambient temperature, subjected to a heat-up time reaching the target temperature for the particular thermal class and then maintained at this temperature for the time period specified for that thermal class. The radio performance was also monitored during the cool down period. Heating of the radio at constant temperature for a prescribed time period will be referred to as “soak” throughout the remainder of the paper. This would simulate a firefighter entering a structure and encountering progressively higher temperatures before reaching the maximum temperature, performing firefighter tasks at this maximum temperature for a period of time, and then exiting the high temperature region. Actual times encountered by a firefighter would depend on the building geometry and conditions within the building. The heat-up time varied depending on the soak temperature, but was held constant for all tests at the same soak temperature. See Figure 2 for a temperature profile displaying a typical heat-up time for Thermal Class III conditions.

Elevated temperature tests were performed using the FEE with the portable radios placed inside the turnout gear pocket. Two thermocouples were located inside the pocket. One monitored the air temperature directly in front of the radio, and the other was attached to the body of the radio. The pocket was able to provide significant thermal protection to the radio, with the air inside the pocket remaining more than 75 °C cooler than the air inside the rest of the tunnel, when the flow rate was 0.9 m/s. Figure 2 is an example of the thermal difference between the pocket air and the tunnel air for a 260 °C temperature soak with airflow 0.9 m/s. When the FEE air speed was increased to 2 m/s, the air inside the pocket still remained at least 57 °C cooler. The air temperature inside the pocket was continually increasing during the temperature soaks, so the difference between the pocket air temperature and the tunnel temperature was even greater at the start of the soaks.

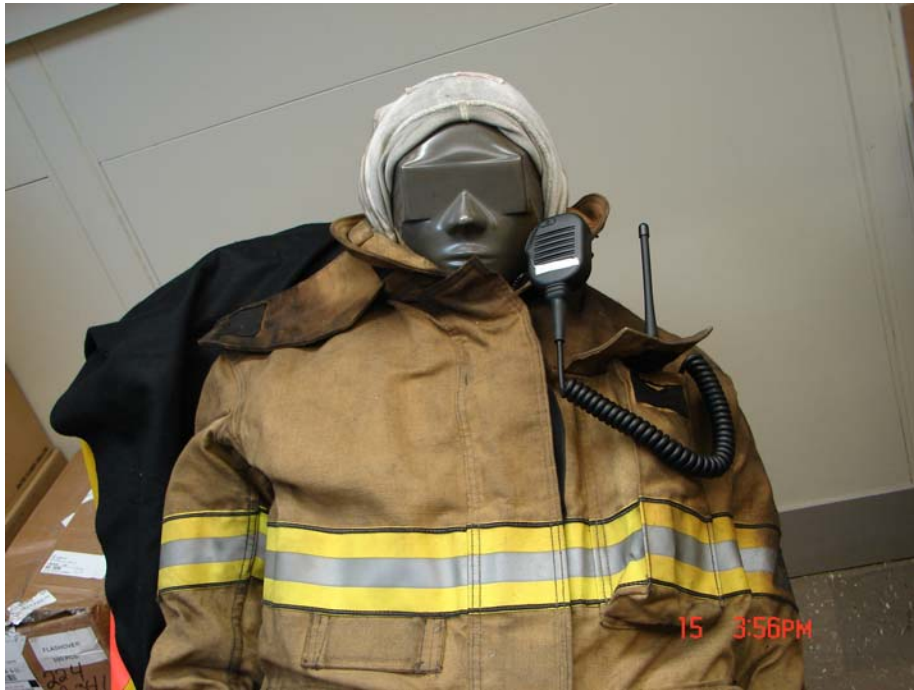
Figure 3 Radio inside turnout coat pocket with speaker/microphone

Testing was also performed with the radios protected inside of a turnout gear style pocket. When portable radios are carried into firefighting environments, the radios are often worn clipped close to the body underneath the turnout gear coat, or placed in pockets located on the outside of the turnout gear coat where they are protected from direct heating by the pocket as displayed on a mannequin in Figure 3.

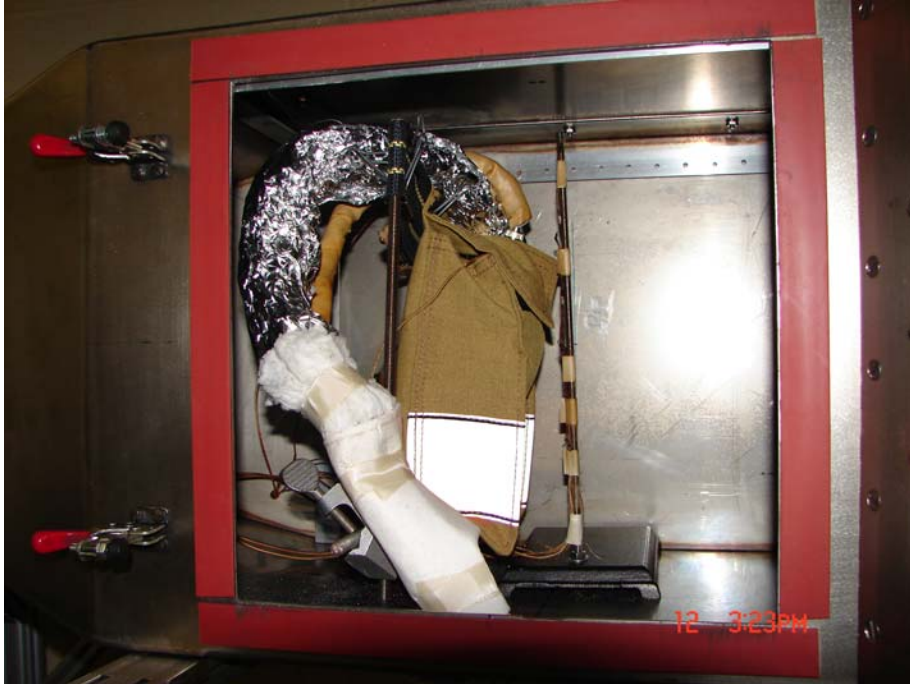
To investigate the operation of these protected radios, a pocket was constructed and used for testing. The pocket was fabricated by a company that produces firefighter turnout gear. It was made from $2.5 \times 10^{-2} \text{ kg/m}^2$ (7.5 oz/yd²) PBI Gold, material that is a blend of 40 % polybenzimidazole and 60 % Kevlar. The pocket measures 100 mm wide by 90 mm deep and is 220 mm tall. It is open at the top for radio insertion, with a flap to cover the top of the radio. Figure 3 shows the pocket suspended from the Kevlar strap inside the FEE. The radio was placed inside the pocket for testing.

Figure 4 Pocket inside FEE for testing. Radio is inside with insulated cable attached. The speaker/microphone cable is the front cable with the aluminum foil at the top while the coax cable connecting the radio output to the spectrum analyzer is the back cable. A thermocouple tree is attached to the ring stand in front of the pocket and the airflow is from the left.

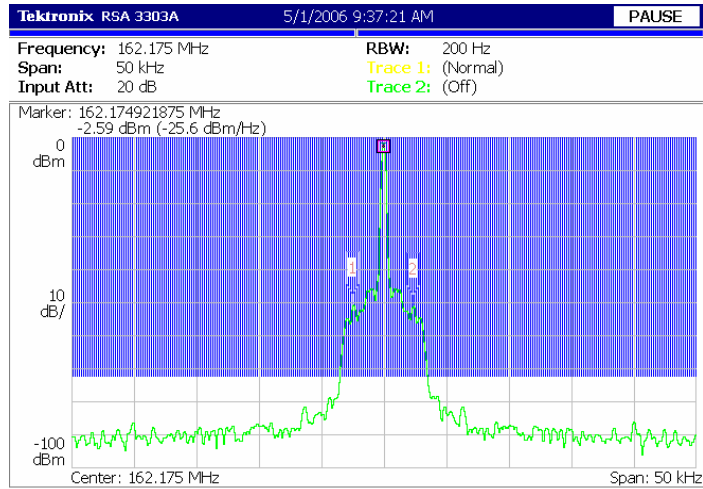
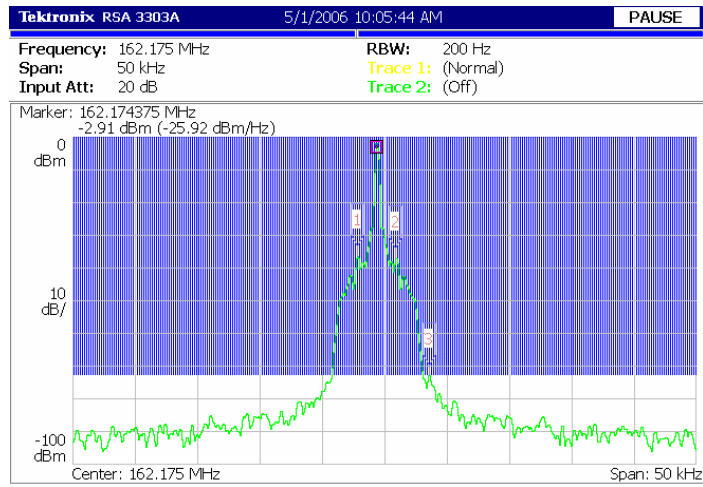
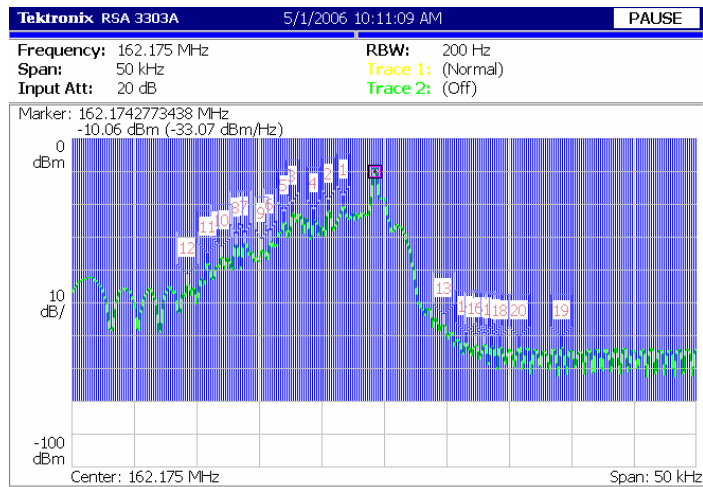
Figure 5 Radio Transmission Signal for Radio C during Thermal Class II Soak

Tests performed at the Thermal Class II conditions of 160 °C for 15 minutes exposed the vulnerabilities of the unprotected radios at higher thermal conditions. As Table 5 shows, all of the radios experienced some degradation of operation at these test conditions. Radio A went completely dead 8.5 to 9.5 minutes into the soak, ceasing to either transmit or receive. For Radio B, there was increased noise on transmission, and the signal shifted off target frequency before the end of the soak. For one of the tests there was also power loss of 2.4 dBm on cool down. Radio C also had performance problems during the Thermal Class II conditions. Its transmission frequency shifted just 5 minutes into the soak in both tests. The signal continued to degrade, before completely stopping at 6 minutes into cool down for the first test, and 4 minutes for the second test. During the repeat test the radio also lost reception on cool down. Figure 5 shows the progression of the signal for Radio C from normal transmission at ambient temperature through the shifted transmission during heating to the degraded signal on cool down. At the end of the 15 minute soak at 160 °C, the centerline frequency had shifted approximately 0.5 kHz lower with and peak intensity drop of approximately 7%. At 5 minutes after the soak, the peak intensity has dropped by a factor of 10 with the centerline frequency shifting by another 0.1 kHz.

a. Signal at ambient temperature

b. Signal at 160 °C for 15 minutes

c. Signal on cool down, 5 minutes after Soak

The radio transmission signal was measured using the signal analyzer. Each radio was programmed to Very High Frequency (VHF) frequency 162.175 MHz assigned for testing purposes. Baseline transmissions were recorded with the radio at ambient room temperatures. When the radio was heated, a deviation of the transmission signal from the programmed

frequency of greater than 0.1 kHz signaled the start of degradation of the transmission signal, and indicated that further problems were imminent.
